Flood Control Project Maintenance
2020 Structure Summary Report
Overall Unit and Item Ratings

Lower San Joaquin Levee District

Ash Slough Drop Structure No. 1

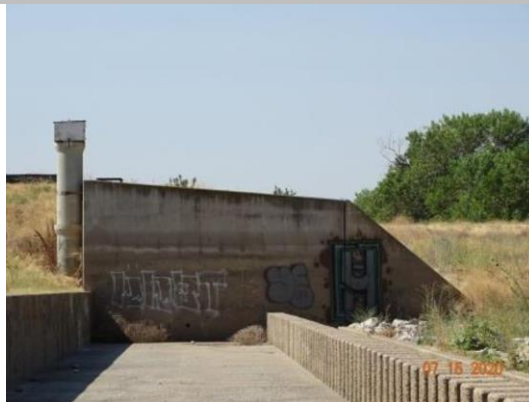
Photo 3 of 4 : ST_2020_NA0010_29_1_20200721_00018.jpg

View of the left wing wall. (2020)

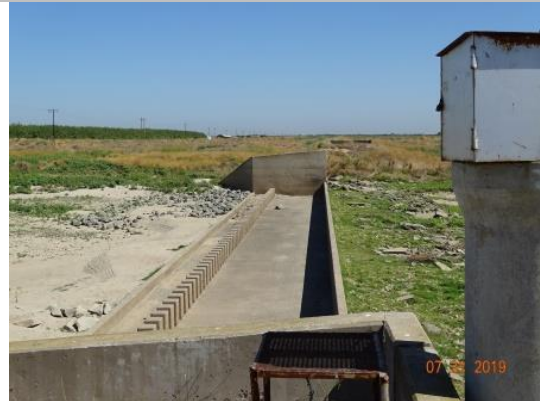
Photo 4 of 4 : ST_2020_NA0010_29_1_20200610_00001.jpg

Overview of structure from the left bank. (2019)

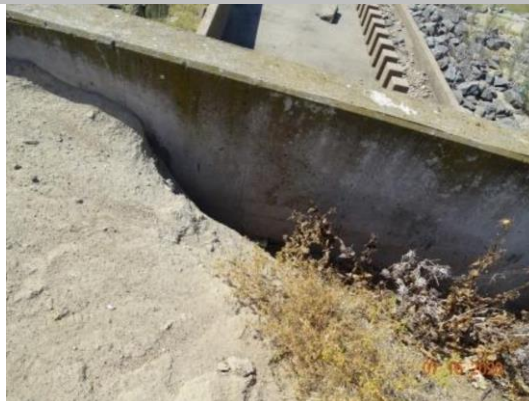
Photo 1 of 3 : ST_2020_NA0010_29_4_20200721_00019.jpg

LM Start	0.00	Rating **	M	Issue No.	4	
LM End	0.00	Issue Type +	Ma	Location *		
Category	Structures & Concrete Lined Channels			GPS Latitude/Longitude		
				Start		End
Item	Erosion / Bank Caving			36.975666 °	36.975666 °	
				-120.382143 °	-120.382143 °	
DWR ID	DWR_NA0010_29_t_2012_4					
Action/Comments						
Inspector Comments: Some caving on right wing wall(north side)

View of erosion along the right wing wall. (2020)

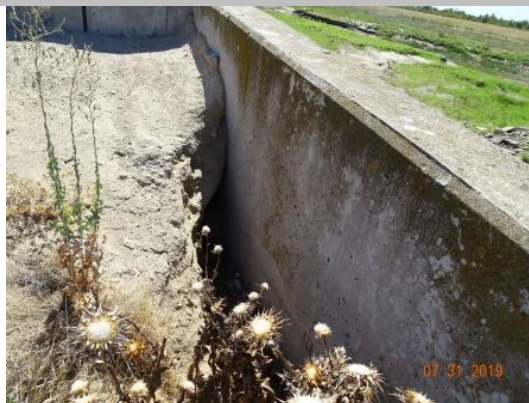
Photo 2 of 3 : ST_2020_NA0010_29_4_20200610_00004.jpg

View of erosion/caving on right wing wall. (2019)

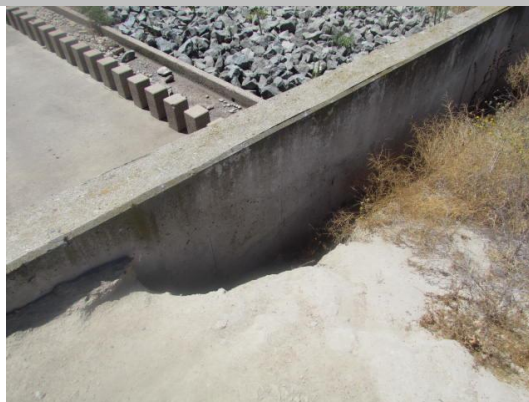
Photo 3 of 3 : ST_2020_NA0010_29_4_20200610_00006.jpg

Looking at erosion/caving on right wing wall on summer 2014.

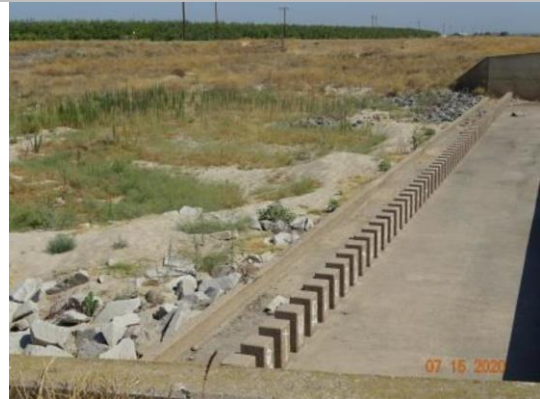
Photo 1 of 1 : ST_2020_NA0010_29_5_20200721_00020.jpg

LM Start	0.00	Rating **	A	Issue No.	5
LM End	0.00	Issue Type +	Ma	Location *	
Category	Structures & Concrete Lined Channels			GPS Latitude/Longitude	
				Start	End
Item	Revetments			36.975666 °	36.975666 °
				-120.382143 °	-120.382143 °
DWR ID	DWR_NA0010_29_t_2012_5				
Action/Comments					
Inspector Comments: Revetment appears to be acceptably maintained.

View of revetment looking towards right wing wall. (2020)

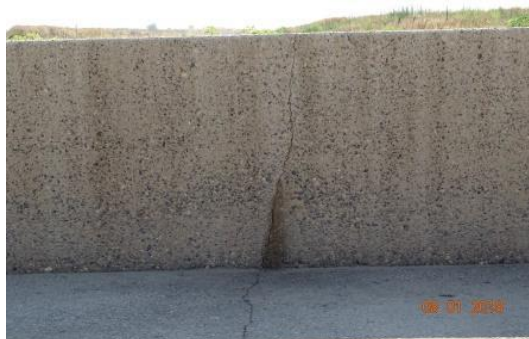
Photo 2 of 2 : ST_2020_NA0010_29_15_20200610_00011.jpg

LM Start	0.00	Rating **	A	Issue No.	15
LM End	0.00	Issue Type +	Ma	Location *	
Category	Structures & Concrete Lined Channels			GPS Latitude/Longitude	
				Start	End
Item	Concrete Surfaces			36.975666 °	36.975666 °
				-120.382143 °	-120.382143 °
DWR ID	DWR_NA0010_29_t_2012_15				
Action/Comments					
Inspector Comments: Negligible small crack at head wall. Concrete just downstream of the energy dissipators is scouring. Recommend monitoring and repair if scour worsens.

Small crack at head wall. (2018)

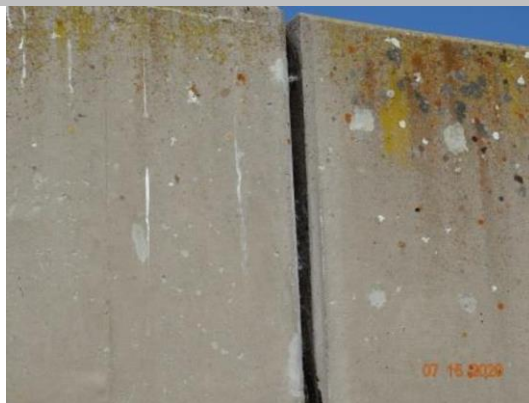
Photo 1 of 1 : ST_2020_NA0010_29_22_20200721_00022.jpg

LM Start	0.00	Rating **	M	Issue No.	22
LM End	0.00	Issue Type +	Ma	Location *	
Category	Structures & Concrete Lined Channels			GPS Latitude/Longitude	
				Start	End
Item	Monolith Joints			36.975666 °	36.975666 °
				-120.382143 °	-120.382143 °
DWR ID	DWR_NA0010_29_t_2012_22				
Action/Comments					
Inspector Comments: Gaskets along the wingwalls are deteriorating.

View of monolith joint at left wing wall. (2020)

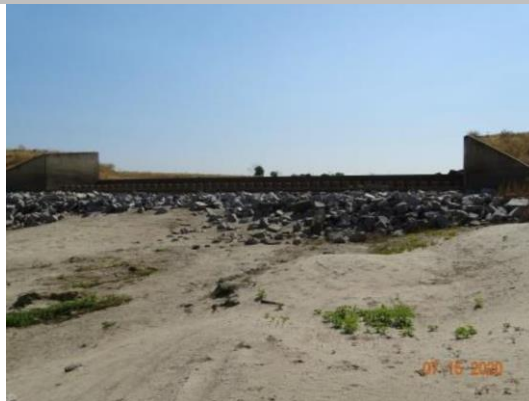
Photo 1 of 3 : ST_2020_NA0010_30_1_20200720_00012.jpg

Overview of the structure. (2020)

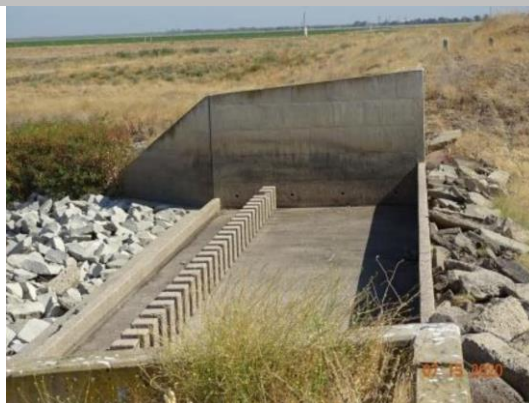
Photo 2 of 3 : ST_2020_NA0010_30_1_20200720_00011.jpg

View of the right wing wall (2020)

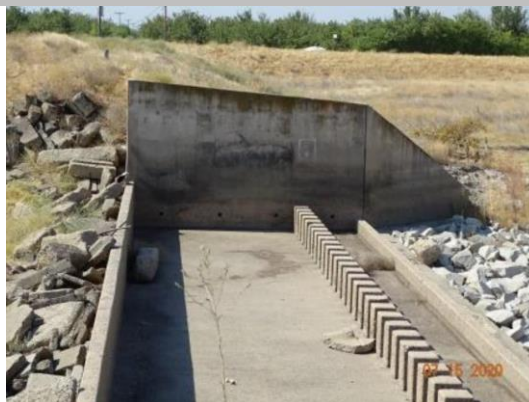
Photo 3 of 3 : ST_2020_NA0010_30_1_20200720_00013.jpg

View of the left wing wall. (2020)

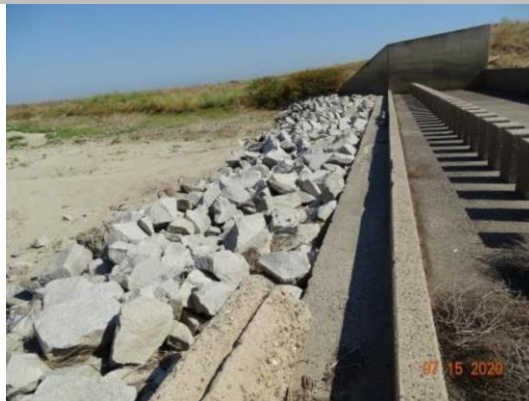
Photo 1 of 2 : ST_2020_NA0010_30_5_20200720_00014.jpg

LM Start	0.00	Rating **	A	Issue No.	5
LM End	0.00	Issue Type +	Ma	Location *	
Category	Structures & Concrete Lined Channels			GPS Latitude/Longitude	
				Start	End
Item	Revetments			36.975706 °	36.975706 °
				-120.374885 °	-120.374885 °
DWR ID	DWR_NA0010_30_t_2012_5				
Action/Comments					
Inspector Comments: Revetment appears to be properly maintained.

View of the downstream revetment. (2020)

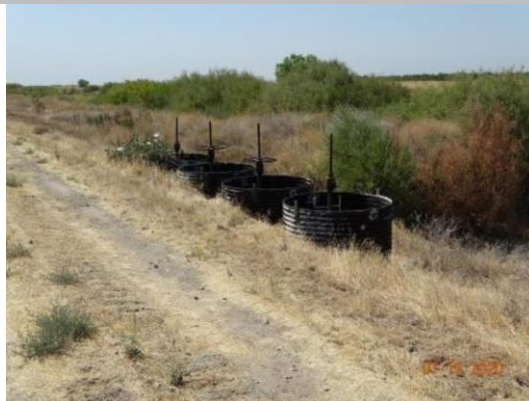
Photo 1 of 3 : ST_2020_NA0010_39_1_20200721_00012.jpg

View of the control gates. (2020)

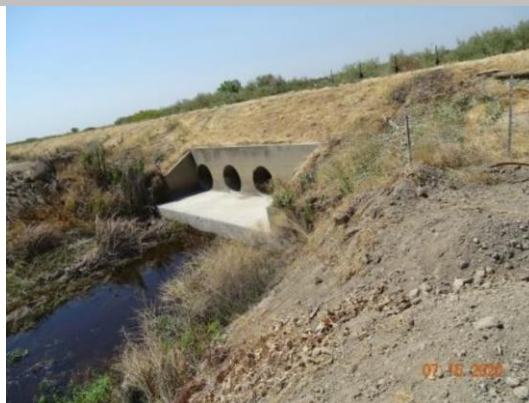
Photo 2 of 3 : ST_2020_NA0010_39_1_20200721_00013.jpg

View of the inlet side of the structure. (2020)

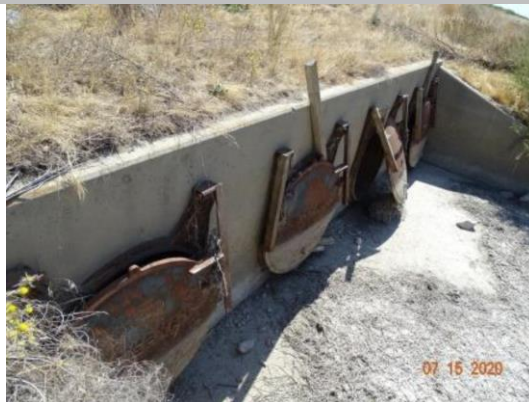
Photo 3 of 3 : ST_2020_NA0010_39_1_20200721_00014.jpg

View of the outlet side of the structure. (2020)

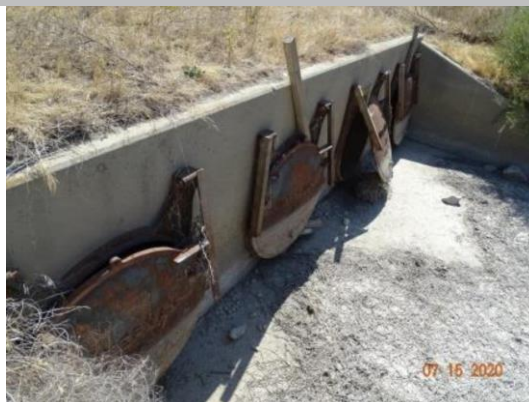
Photo 1 of 2 : ST_2020_NA0010_39_6_20200721_00015.jpg

LM Start	0.00	Rating **	M	Issue No.	6
LM End	0.00	Issue Type +	Ma	Location *	
Category	Structures & Concrete Lined Channels			GPS Latitude/Longitude	
				Start	End
Item	Encroachments			36.975418 °	36.975418 °
				-120.359578 °	-120.359578 °
DWR ID	DWR_NA0010_39_t_2012_6				
Action/Comments					
Inspector Comments: Wood planks used to prop open outlet flap gates.

Wood planks used to prop open the flap gates. (2020)

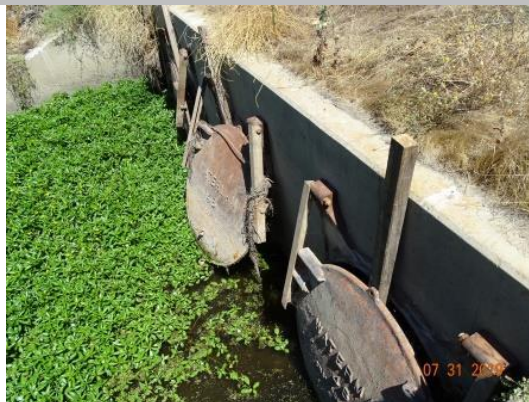
Photo 2 of 2 : ST_2020_NA0010_39_6_20200610_00004.jpg

Wood planks used to prop open flap gates. (2019)

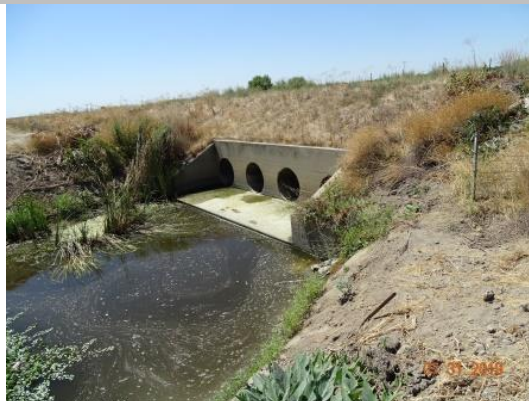
Photo 1 of 2 : ST_2020_NA0010_39_7_20200610_00005.jpg

LM Start	0.00	Rating **	A	Issue No.	7
LM End	0.00	Issue Type +	Ma	Location *	
Category	Structures & Concrete Lined Channels			GPS Latitude/Longitude	
				Start	End
Item	Culverts: Inlets / Outlets			36.975418 °	36.975418 °
				-120.359578 °	-120.359578 °
DWR ID	DWR_NA0010_39_t_2012_7				
Action/Comments					
Inspector Comments: Culverts are clear of obstructions. Wood planks were used to prop open the flap gates (see issue 6).

View of inlet side of structure. (2019)

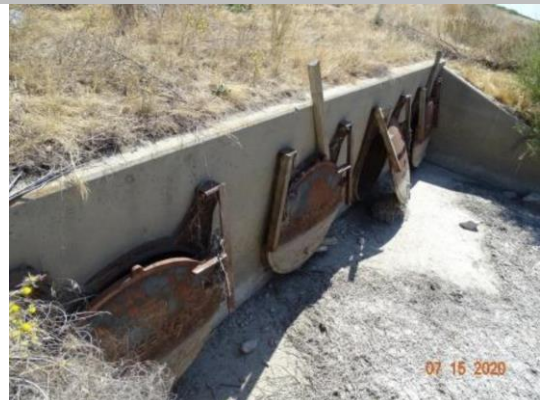
Photo 1 of 1 : ST_2020_NA0010_39_11_20200721_00016.jpg

LM Start	0.00	Rating **	A	Issue No.	11
LM End	0.00	Issue Type +	Ma	Location *	
Category	Structures & Concrete Lined Channels	GPS Latitude/Longitude			
		Start		End	
Item	Flap Gates	36.975418 °		36.975418 °	
		-120.359578 °		-120.359578 °	
DWR ID	DWR_NA0010_39_t_2012_11				
Action/Comments					
Inspector Comments: Flap gates have been propped open with wood planks.

View of flap gates at outlet of the structure. (2020)

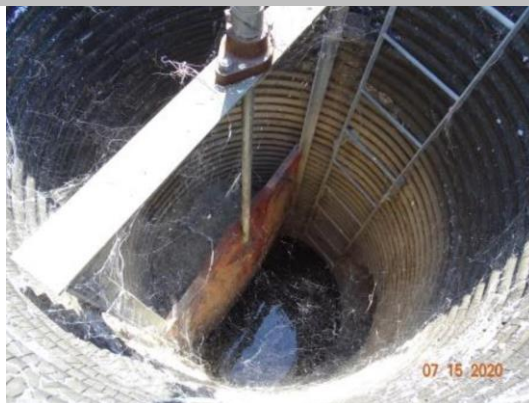
Photo 1 of 2 : ST_2020_NA0010_39_12_20200721_00017.jpg

LM Start	0.00	Rating **	A	Issue No.	12
LM End	0.00	Issue Type +	Ma	Location *	
Category	Structures & Concrete Lined Channels			GPS Latitude/Longitude	
				Start	End
Item	Sluice/Slide Gates			36.975418 °	36.975418 °
				-120.359578 °	-120.359578 °
DWR ID	DWR_NA0010_39_t_2012_12				
Action/Comments					
Inspector Comments: Slide gates appear to be in good condition. Vegetation caught in slide gate should be cleared.

Typical view of slide gate. (2020)

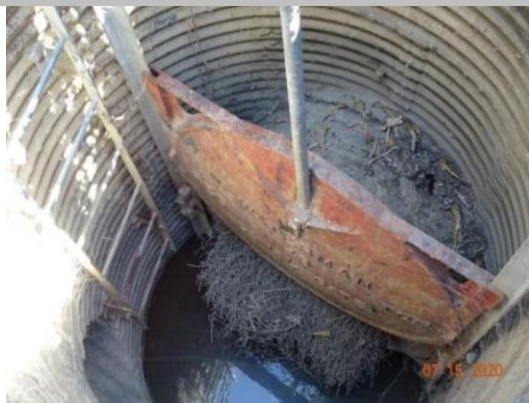
Photo 2 of 2 : ST_2020_NA0010_39_12_20200721_00018.jpg

Vegetation caught under the middle slide gate. (2020)

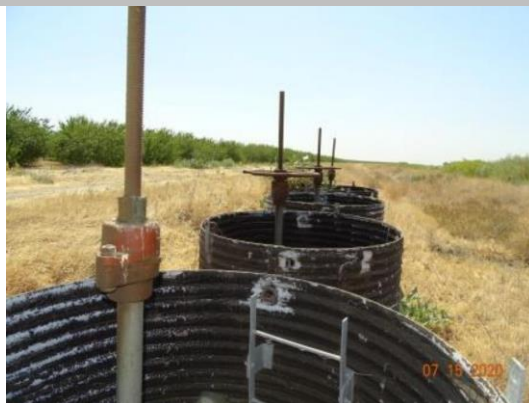
Photo 1 of 2 : ST_2020_NA0010_39_14_20200721_00021.jpg

LM Start	0.00	Rating **	M	Issue No.	14
LM End	0.00	Issue Type +	Ma	Location *	
Category	Structures & Concrete Lined Channels			GPS Latitude/Longitude	
				Start	End
Item	Manual Gate Operators			36.975418 °	36.975418 °
				-120.359578 °	-120.359578 °
DWR ID	DWR_NA0010_39_t_2012_14				
Action/Comments					
Inspector Comments: Missing wheel on two of four screw gates. One wheel handle is broken. Wheel handles could not be operated. Manual operator components should be greased and maintained.

View of the manual gate operators. (2020)

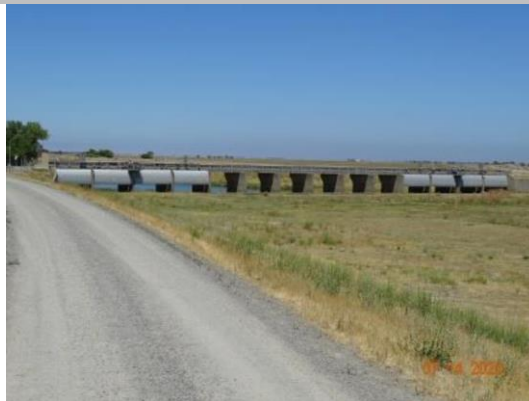
Photo 1 of 3 : ST_2020_NA0010_44_1_20200720_00016.jpg

Looking at the upstream side of the structure from the left bank. (2020)

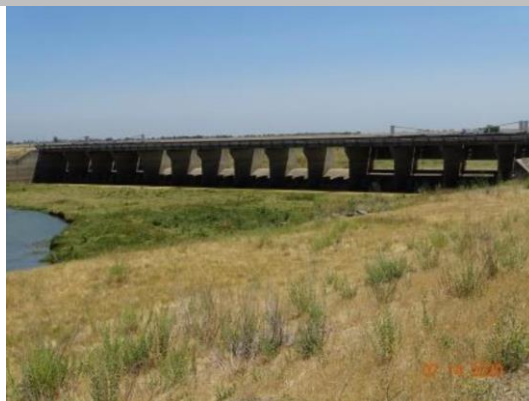
Photo 2 of 3 : ST_2020_NA0010_44_1_20200720_00017.jpg

View of the downstream side of the structure from the left bank. (2020)

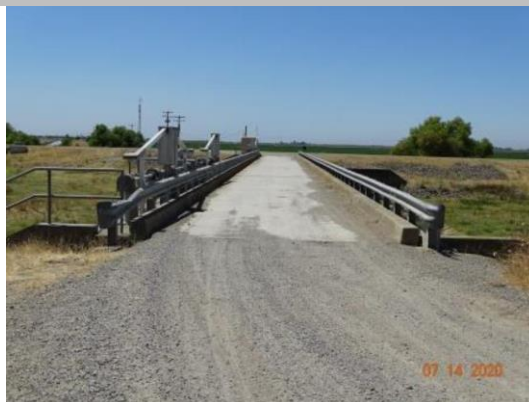
Photo 3 of 3 : ST_2020_NA0010_44_1_20200720_00015.jpg

View across the top of the structure. (2020)

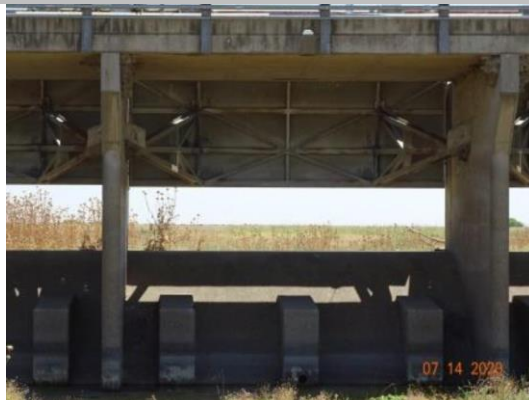
Photo 1 of 1 : ST_2020_NA0010_44_7_20200720_00018.jpg

LM Start	0.00	Rating **	A	Issue No.	7	
LM End	0.00	Issue Type +	Ma	Location *		
Category	Structures & Concrete Lined Channels			GPS Latitude/Longitude		
				Start		End
Item	Culverts: Inlets / Outlets			37.201538 °	37.201538 °	
				-120.694813 °	-120.694813 °	
DWR ID	DWR_NA0010_44_t_2012_7					
Action/Comments						
Inspector Comments: No debris blocking culverts.

Typical view of outlets. (2020)

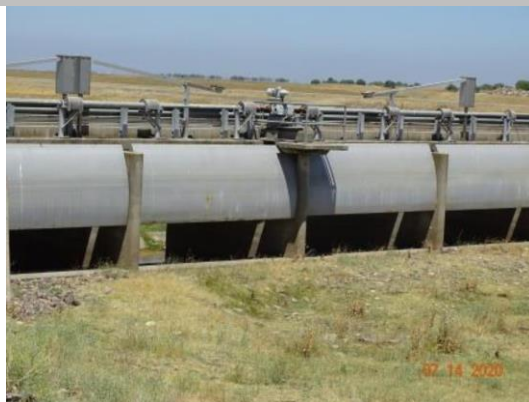
Photo 1 of 1 : ST_2020_NA0010_44_12_20200720_00019.jpg

LM Start	0.00	Rating **	A	Issue No.	12
LM End	0.00	Issue Type +	Ma	Location *	
Category	Structures & Concrete Lined Channels			GPS Latitude/Longitude	
				Start	End
Item	Sluice/Slide Gates			37.201538 °	37.201538 °
				-120.694813 °	-120.694813 °
DWR ID	DWR_NA0010_44_t_2012_12				
Action/Comments					
Inspector Comments: No visible damage, sediment or obstructions identified.

View of the radial gates. (2020)

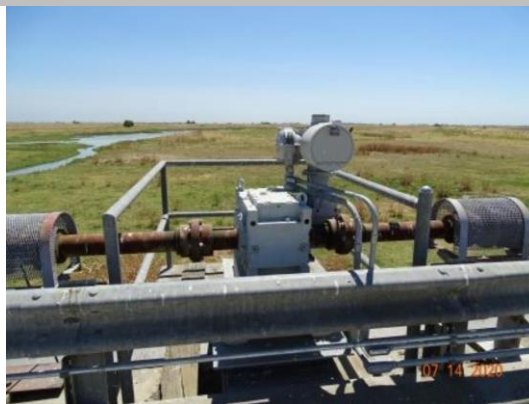
Photo 1 of 3 : ST_2020_NA0010_44_13_20200720_00020.jpg

LM Start	0.00	Rating **	A	Issue No.	13
LM End	0.00	Issue Type +	Ma	Location *	
Category	Structures & Concrete Lined Channels	GPS Latitude/Longitude			
		Start		End	
Item	Electric Gate Operators	37.201538 °		37.201538 °	
		-120.694813 °		-120.694813 °	
DWR ID	DWR_NA0010_44_t_2012_13				
Action/Comments					
Inspector Comments: Electrical gates appear to be in proper working condition.

Typical view of electrical gates on upstream side of structure. (2020)

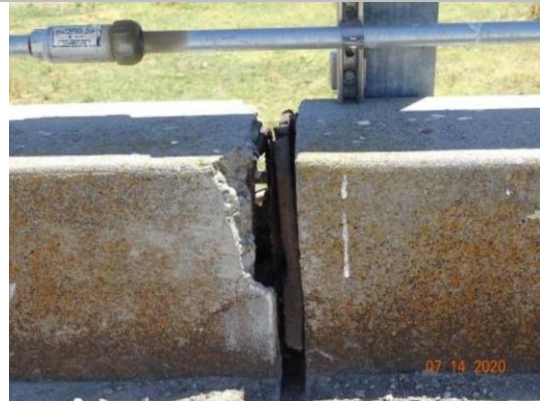
Photo 1 of 1 : ST_2020_NA0010_44_15_20200720_00021.jpg

LM Start	0.00	Rating **	A	Issue No.	15
LM End	0.00	Issue Type +	Ma	Location *	
Category	Structures & Concrete Lined Channels			GPS Latitude/Longitude	
				Start	End
Item	Concrete Surfaces			37.201538 °	37.201538 °
				-120.694813 °	-120.694813 °
DWR ID	DWR_NA0010_44_t_2012_15				
Action/Comments					
Inspector Comments: Exposed rebar at expansion joint on upstream side of structure.

Exposed rebar at expansion joint on upstream side of structure. (2020)

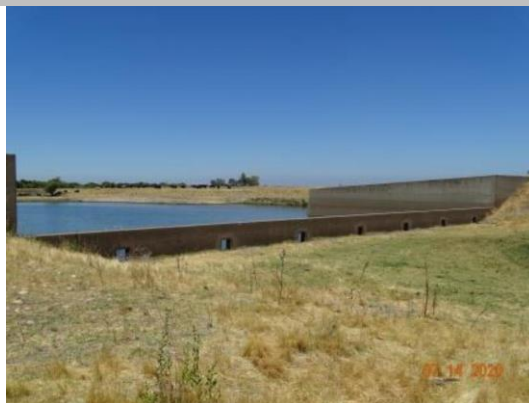
Photo 1 of 4 : ST_2020_NA0010_31_1_20200720_00010.jpg

Looking at the upstream side of the structure from the left bank. (2020)

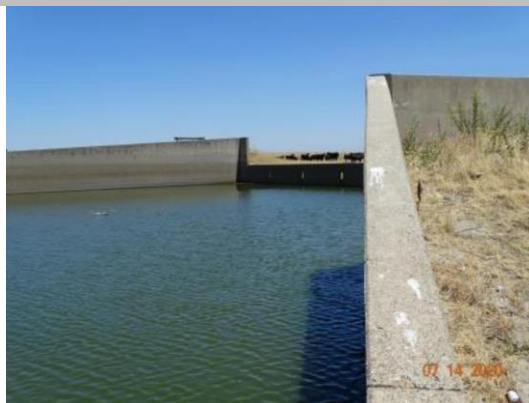
Photo 2 of 4 : ST_2020_NA0010_31_1_20200720_00009.jpg

View of the downstream side of the structure from the left bank. (2020)

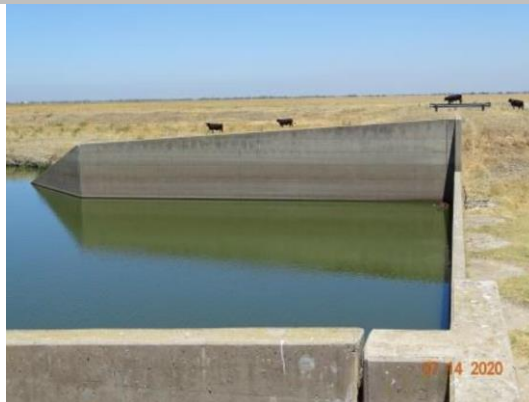
Photo 3 of 4 : ST_2020_NA0010_31_1_20200720_00008.jpg

View of the right wing wall. (2020)

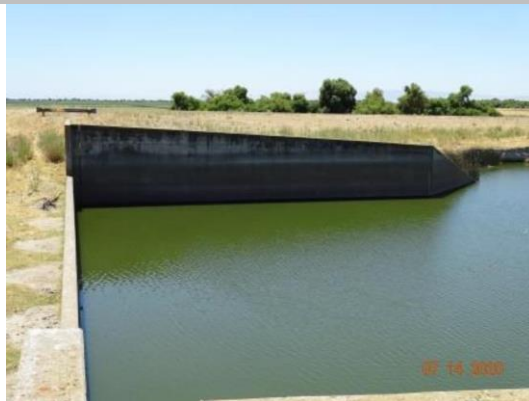
Photo 4 of 4 : ST_2020_NA0010_31_1_20200720_00011.jpg

View of the left wing wall. (2020)

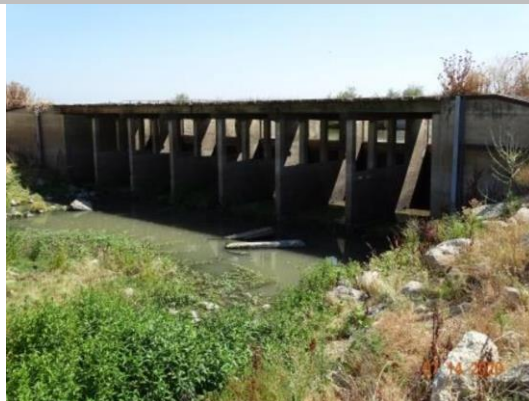
Photo 1 of 3 : ST_2020_NA0010_49_1_20200717_00020.jpg

LM Start	0.00	Rating **	N	Issue No.	1
LM End	0.00	Issue Type +	Ma	Location *	
Category	Structures & Concrete Lined Channels			GPS Latitude/Longitude	
				Start	End
Item	Photo Documentation			37.219637 °	37.219637 °
				-120.698018 °	-120.698018 °
DWR ID	DWR_NA0010_49_t_2018_1				
Action/Comments					
Inspector Comments: The control structure has structural defects at multiple locations. The LMA appears to have stabilized the structure with external steel reinforcements (see photos throughout).

View of outlet side of the structure. (2020)

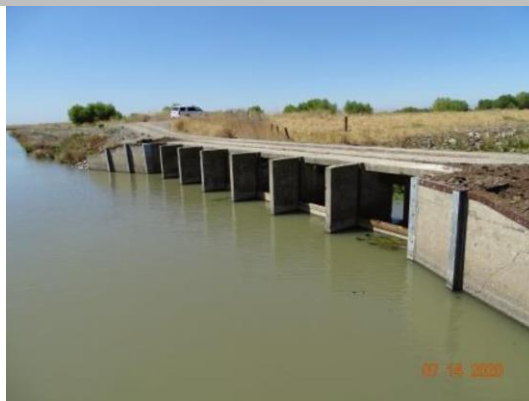
Photo 2 of 3 : ST_2020_NA0010_49_1_20200717_00019.jpg

View of inlet side of the structure. (2020)

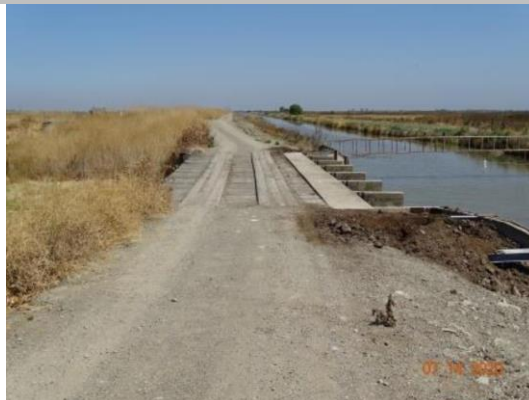
Photo 3 of 3 : ST_2020_NA0010_49_1_20200717_00018.jpg

View across the top of the structure. (2020)

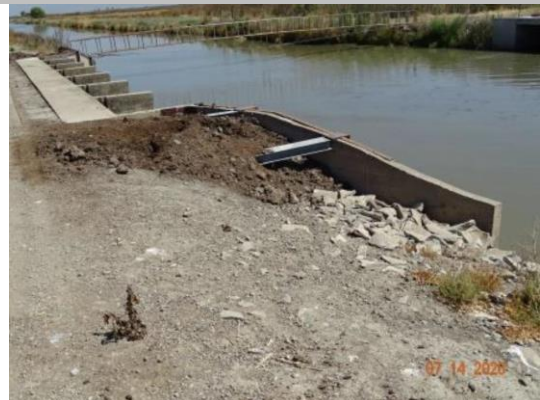
Photo 1 of 2 : ST_2020_NA0010_49_4_20200717_00021.jpg

LM Start	0.00	Rating **	A	Issue No.	4
LM End	0.00	Issue Type +	Ma	Location *	
Category	Structures & Concrete Lined Channels	GPS Latitude/Longitude			
		Start		End	
Item	Erosion / Bank Caving	37.219637 °		37.219637 °	
		-120.698018 °		-120.698018 °	
DWR ID	DWR_NA0010_49_t_2012_4				
Action/Comments					
Inspector Comments: LMA brought in concrete revetment for the minor erosion at the left headwall.

Concrete revetment placed at the left headwall. (2020)

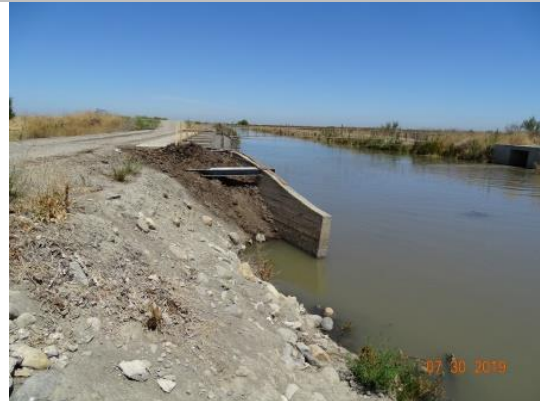
Photo 2 of 2 : ST_2020_NA0010_49_4_20200610_00004.jpg

LM Start	0.00	Rating **	A	Issue No.	4 (cont)	
LM End	0.00	Issue Type +	Ma	Location *		
Category	Structures & Concrete Lined Channels			GPS Latitude/Longitude		
				Start		End
Item	Erosion / Bank Caving			37.219637 °		37.219637 °
				-120.698018 °		-120.698018 °
DWR ID	DWR_NA0010_49_t_2012_4					
Action/Comments						
Inspector Comments: LMA brought in concrete revetment for the minor erosion at the left headwall.

View of left headwall, possible erosion on landside of wall. (2019)

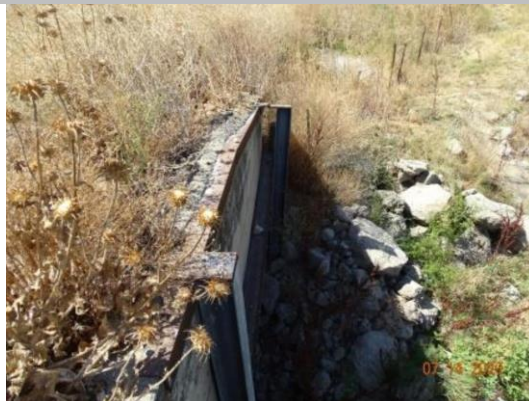
Photo 1 of 5 : ST_2020_NA0010_49_16_20200717_00024.jpg

LM Start	0.00	Rating **	M	Issue No.	16
LM End	0.00	Issue Type +	Ma	Location *	
Category	Structures & Concrete Lined Channels			GPS Latitude/Longitude	
				Start	End
Item	Concrete Tilting / Settlement			37.219637 °	37.219637 °
				-120.698018 °	-120.698018 °
DWR ID	DWR_NA0010_49_t_2012_16				
Action/Comments					
Inspector Comments: Concrete tilting/settlement on upstream and downstream left wing walls has been stabilized by the LMA. Tilting is still visible but installed braces appear to be stabilizing the wingwalls.

Looking at brace on left wing wall on downstream side of structure. (2020)

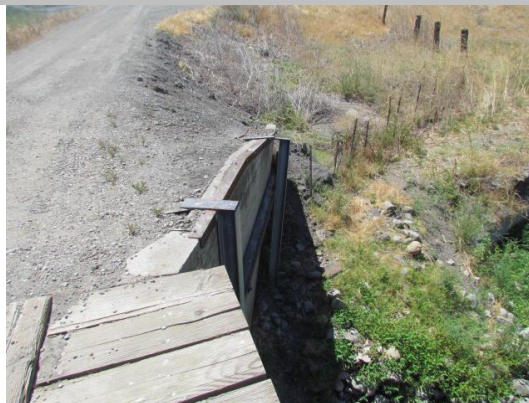
Photo 2 of 5 : ST_2020_NA0010_49_16_20200610_00013.jpg

Looking at brace on left wing wall on downstream side of structure. Summer 2012

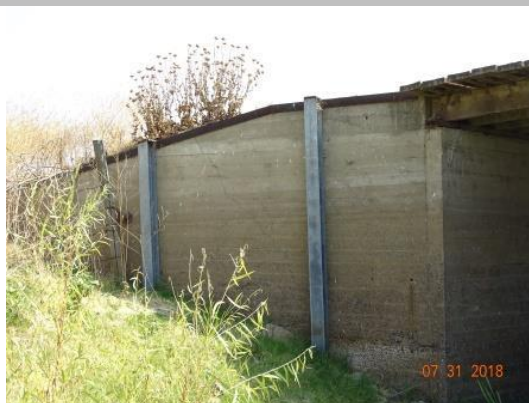
Photo 3 of 5 : ST_2020_NA0010_49_16_20200610_00014.jpg

Looking at braces on downstream right wing wall. (2018)

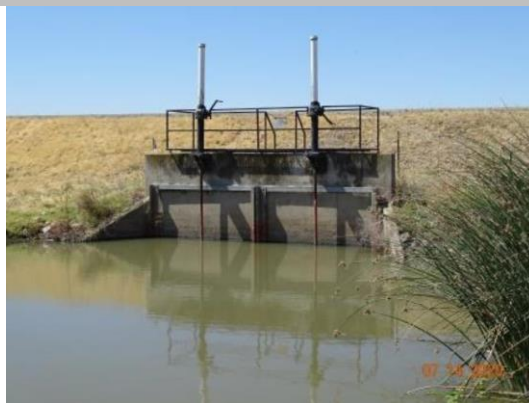
Photo 1 of 3 : ST_2020_NA0010_50_1_20200717_00011.jpg

View of upstream side of the structure. (2020)

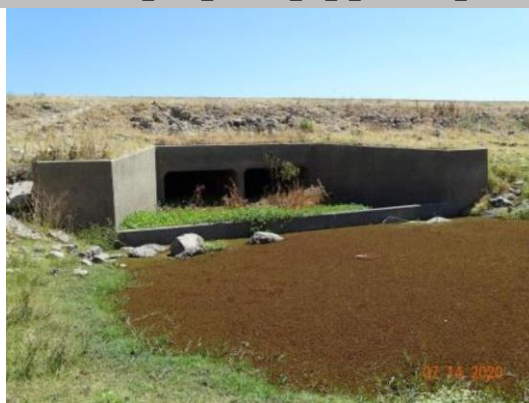
Photo 2 of 3 : ST_2020_NA0010_50_1_20200717_00013.jpg

View of downstream side of the structure. (2020)

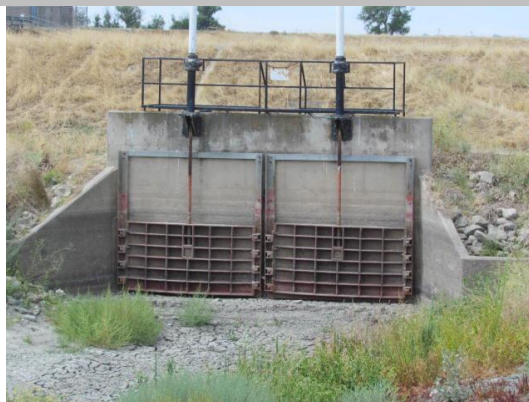
Photo 3 of 3 : ST_2020_NA0010_50_1_20200610_00003.jpg

Looking at upstream side of structure. (2015)

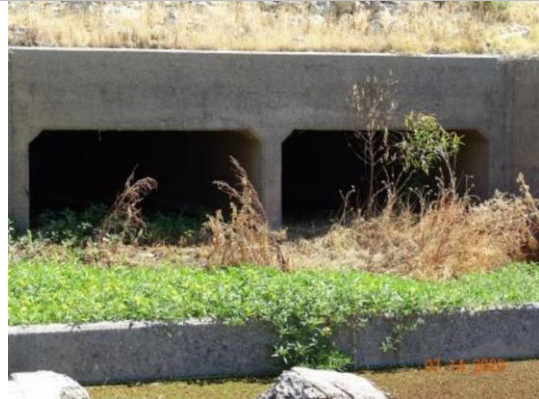
Photo 1 of 1 : ST_2020_NA0010_50_7_20200717_00014.jpg

LM Start	0.00	Rating **	A	Issue No.	7
LM End	0.00	Issue Type +	Ma	Location *	
Category	Structures & Concrete Lined Channels			GPS Latitude/Longitude	
				Start	End
Item	Culverts: Inlets / Outlets			37.205787 °	37.205787 °
				-120.696838 °	-120.696838 °
DWR ID	DWR_NA0010_50_t_2012_7				
Action/Comments					
Inspector Comments: No damage or obstructions of the culverts observed.

Looking at outlets of the structure. (2020)

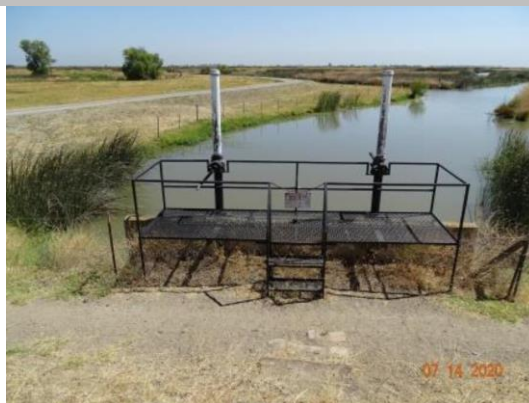
Photo 1 of 1 : ST_2020_NA0010_50_14_20200717_00015.jpg

LM Start	0.00	Rating **	A	Issue No.	14
LM End	0.00	Issue Type +	Ma	Location *	
Category	Structures & Concrete Lined Channels	GPS Latitude/Longitude			
		Start		End	
Item	Manual Gate Operators	37.205787 °		37.205787 °	
		-120.696838 °		-120.696838 °	
DWR ID	DWR_NA0010_50_t_2012_14				
Action/Comments					
Inspector Comments: Manual gates were in good working condition.

View of manual gate controls. (2020)

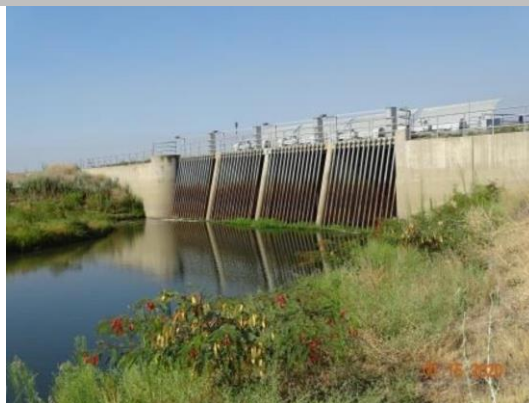
Photo 1 of 3 : ST_2020_NA0010_64_1_20200720_00010.jpg

LM Start	0.00	Rating **	N	Issue No.	1
LM End	0.00	Issue Type +	Ma	Location *	
Category	Structures & Concrete Lined Channels			GPS Latitude/Longitude	
				Start	End
Item	Photo Documentation			36.773292 °	36.773292 °
				-120.285206 °	-120.285206 °
DWR ID	DWR_NA0010_64_t_2017_1				
Action/Comments					
Inspector Comments: Structure appears to be properly maintained.

View of upstream side of the structure. (2020)

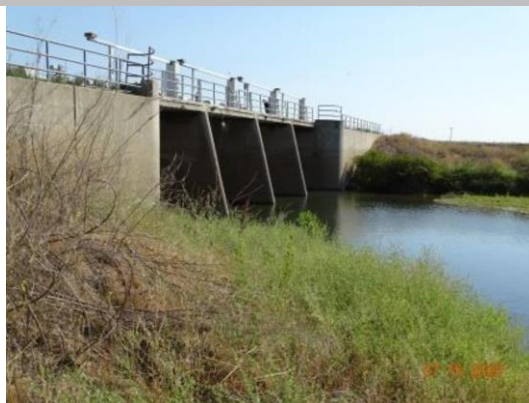
Photo 2 of 3 : ST_2020_NA0010_64_1_20200720_00011.jpg

View of downstream side of the structure. (2020)

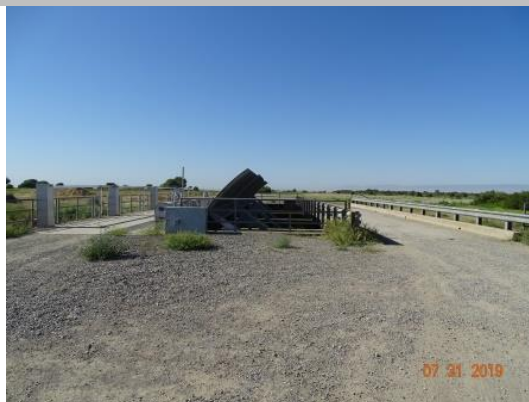
Photo 3 of 3 : ST_2020_NA0010_64_1_20200610_00003.jpg

View of top of the structure from right bank. (2019)

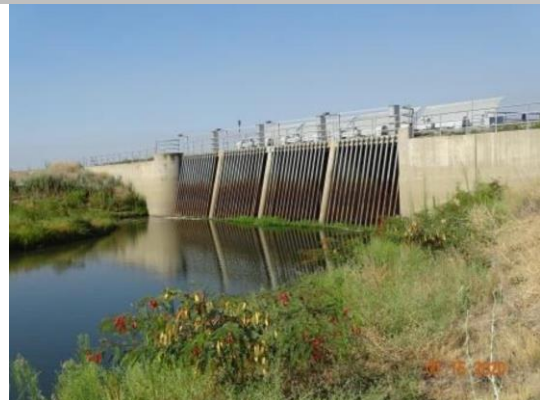
Photo 1 of 1 : ST_2020_NA0010_64_10_20200720_00012.jpg

LM Start	0.00	Rating **	A	Issue No.	10
LM End	0.00	Issue Type +	Ma	Location *	
Category	Structures & Concrete Lined Channels	GPS Latitude/Longitude			
		Start	End		
Item	Trash Racks	36.773292 °		36.773292 °	
		-120.285206 °		-120.285206 °	
DWR ID	DWR_NA0010_64_t_2017_10				
Action/Comments					
Inspector Comments: Trash racks appear to be in good condition.

View of trash racks. (2020)

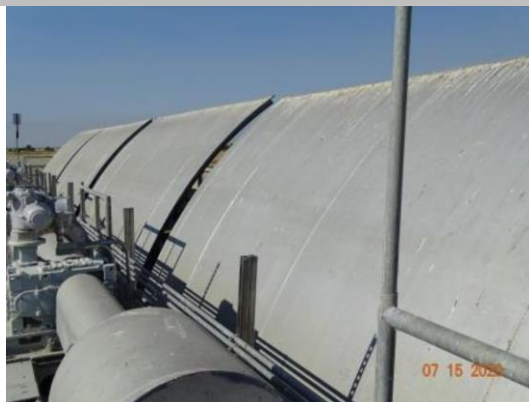
Photo 1 of 2 : ST_2020_NA0010_64_12_20200720_00013.jpg

LM Start	0.00	Rating **	A	Issue No.	12
LM End	0.00	Issue Type +	Ma	Location *	
Category	Structures & Concrete Lined Channels	GPS Latitude/Longitude			
		Start		End	
Item	Sluice/Slide Gates	36.773292 °		36.773292 °	
		-120.285206 °		-120.285206 °	
DWR ID	DWR_NA0010_64_t_2017_12				
Action/Comments					
Inspector Comments: Gates are in good working condition.

View of the radial gates. (2020)

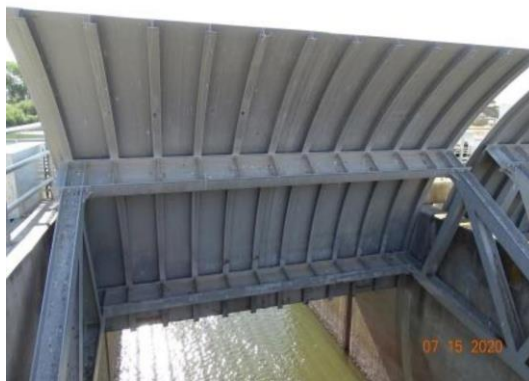
Photo 2 of 2 : ST_2020_NA0010_64_12_20200720_00014.jpg

Typical view of the gates. (2020)

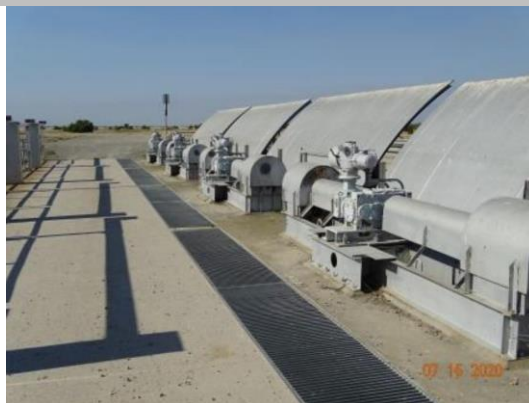
Photo 1 of 2 : ST_2020_NA0010_64_13_20200720_00015.jpg

LM Start	0.00	Rating **	A	Issue No.	13
LM End	0.00	Issue Type +	Ma	Location *	
Category	Structures & Concrete Lined Channels			GPS Latitude/Longitude	
				Start	End
Item	Electric Gate Operators			36.773292 °	36.773292 °
				-120.285206 °	-120.285206 °
DWR ID	DWR_NA0010_64_t_2017_13				
Action/Comments					
Inspector Comments: Electric gate operators appear to be in good working condition.

View of the electric gate operators. (2020)

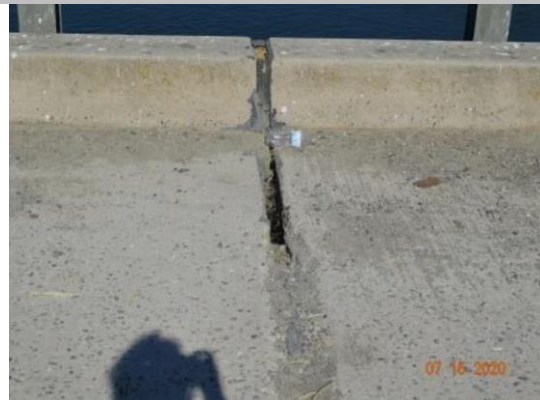
Photo 1 of 1 : ST_2020_NA0010_64_22_20200720_00016.jpg

LM Start	0.00	Rating **	A	Issue No.	22
LM End	0.00	Issue Type +	Ma	Location *	
Category	Structures & Concrete Lined Channels	GPS Latitude/Longitude			
		Start		End	
Item	Monolith Joints	36.773292 °		36.773292 °	
		-120.285206 °		-120.285206 °	
DWR ID	DWR_NA0010_64_t_2017_22				
Action/Comments					
Inspector Comments: Noted deterioration of the expansion joint on the downstream side of the roadway. Recommend monitoring and repairing if the deterioration worsens.

View of expansion joint on the downstream side of the top roadway.
(2020)

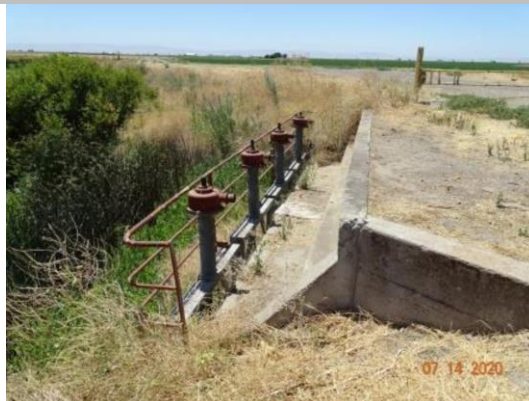
Photo 1 of 2 : ST_2020_NA0010_66_1_20200720_00014.jpg

View of the upstream side of the structure. (2020)

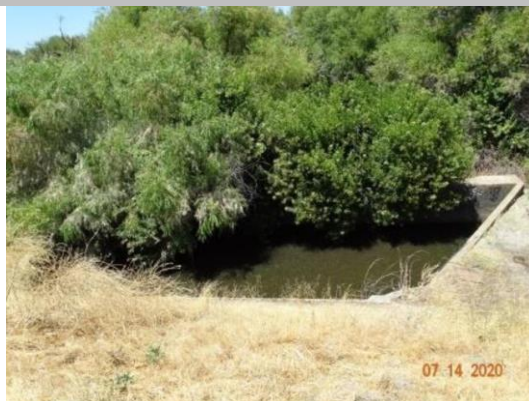
Photo 2 of 2 : ST_2020_NA0010_66_1_20200720_00013.jpg

View of the downstream side of the structure. (2020)

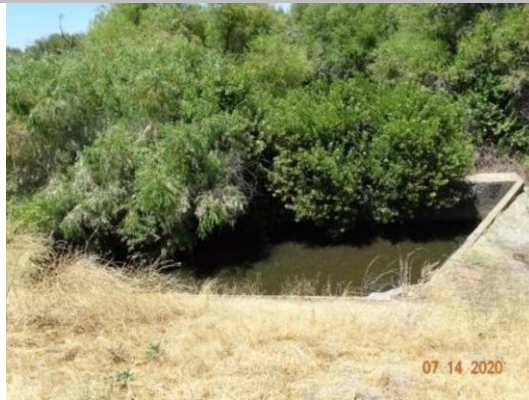
Photo 1 of 1 : ST_2020_NA0010_66_2_20200720_00015.jpg

LM Start	0.00	Rating **	M	Issue No.	2
LM End	0.00	Issue Type +	Ma	Location *	
Category	Structures & Concrete Lined Channels			GPS Latitude/Longitude	
				Start	End
Item	Vegetation & Obstructions			37.112360 °	37.112360 °
				-120.589598 °	-120.589598 °
DWR ID	DWR_NA0010_66_t_2017_2				
Action/Comments					
Inspector Comments: Vegetation growing at the downstream side of structure.

Trees growing over the downstream side of the structure. (2020)

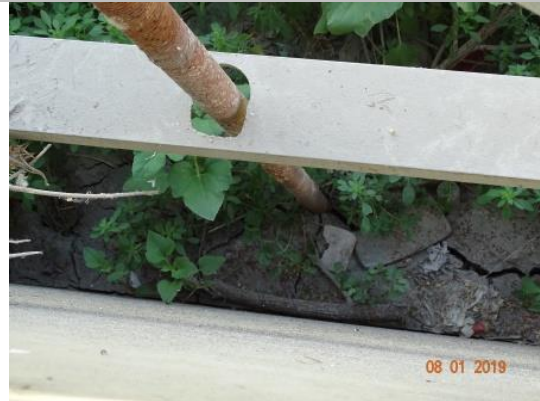
Photo 1 of 1 : ST_2020_NA0010_66_3_20200610_00005.jpg

LM Start	0.00	Rating **	U	Issue No.	3
LM End	0.00	Issue Type +	Ma	Location *	
Category	Structures & Concrete Lined Channels			GPS Latitude/Longitude	
				Start	End
Item	Shoaling / Sedimentation			37.112360 °	37.112360 °
				-120.589598 °	-120.589598 °
DWR ID	DWR_NA0010_66_t_2017_3				
Action/Comments					
Inspector Comments: Sedimentation blocking inlet and function of slide gates.

Inlet gates buried under sedimentation. (2019)

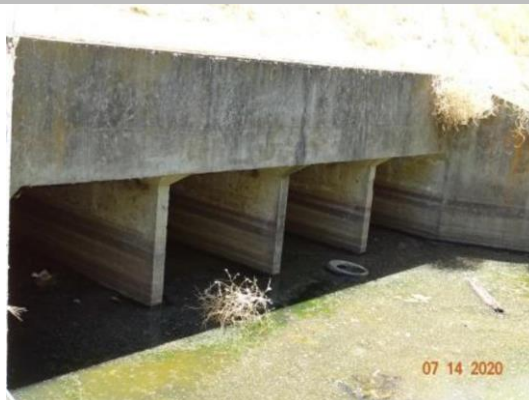
Photo 1 of 2 : ST_2020_NA0010_66_7_20200720_00016.jpg

LM Start	0.00	Rating **	A	Issue No.	7
LM End	0.00	Issue Type +	Ma	Location *	
Category	Structures & Concrete Lined Channels			GPS Latitude/Longitude	
				Start	End
Item	Culverts: Inlets / Outlets			37.112360 °	37.112360 °
				-120.589598 °	-120.589598 °
DWR ID	DWR_NA0010_66_t_2017_7				
Action/Comments					
Inspector Comments: Culverts are in good condition but there is sedimentation built up above the inlets/slide gates see issue 3.

View of culvert outlet. (2020)

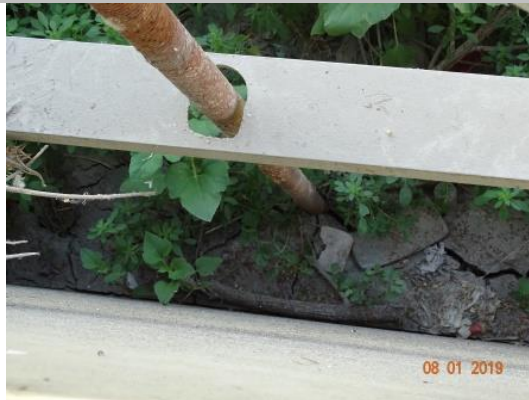
Photo 2 of 2 : ST_2020_NA0010_66_7_20200610_00007.jpg

Sedimentation built up above slide gate. (2019)

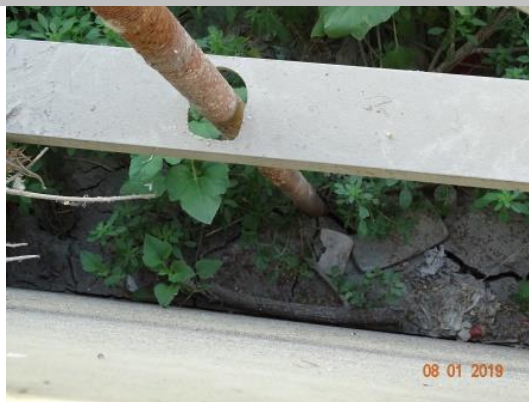
Photo 1 of 2 : ST_2020_NA0010_66_12_20200610_00009.jpg

View of slide gate with sedimentation. (2019)

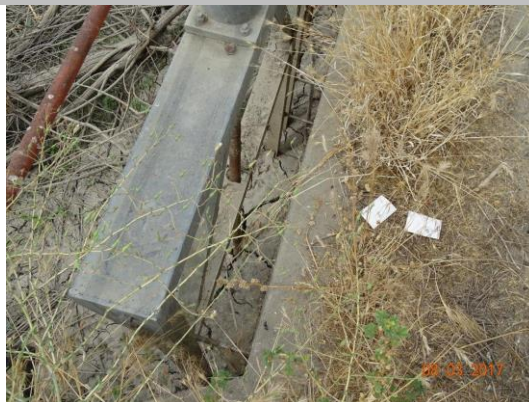
Photo 2 of 2 : ST_2020_NA0010_66_12_20200610_00010.jpg

View of slide gate with sedimentation. (2017)

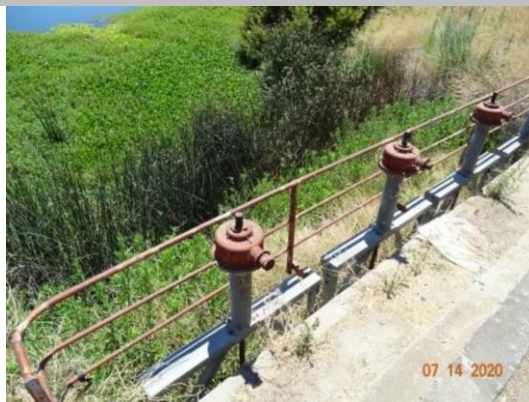
Photo 1 of 2 : ST_2020_NA0010_66_14_20200720_00018.jpg

LM Start	0.00	Rating **	A	Issue No.	14
LM End	0.00	Issue Type +	Ma	Location *	
Category	Structures & Concrete Lined Channels	GPS Latitude/Longitude			
		Start		End	
Item	Manual Gate Operators	37.112360 °		37.112360 °	
		-120.589598 °		-120.589598 °	
DWR ID	DWR_NA0010_66_t_2017_14				
Action/Comments					
Inspector Comments: All manual gates operators appear to be in proper working condition. District caps off manual operation stem to secure gates.

View of the manual gate operators. (2020)

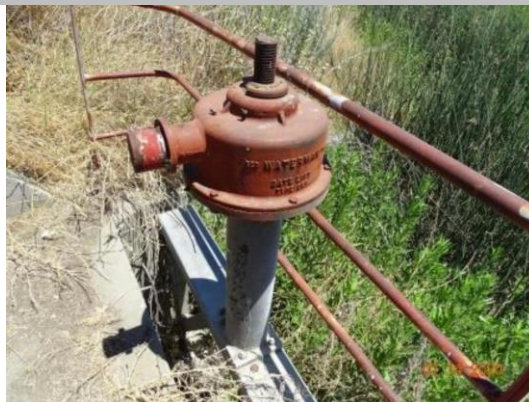
Photo 2 of 2 : ST_2020_NA0010_66_14_20200720_00017.jpg

Typical view of the manual gate operators. (2020)

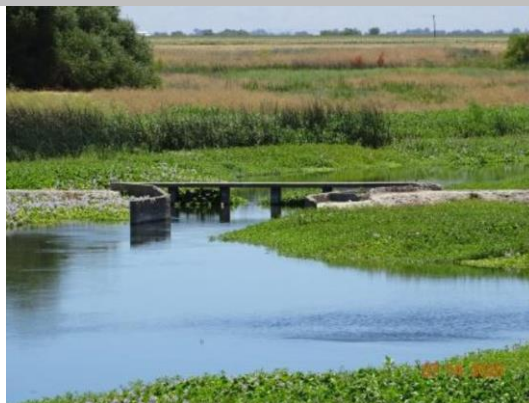
Photo 1 of 3 : ST_2020_NA0010_67_1_20200720_00007.jpg

View of the downstream side of the structure. (2020)

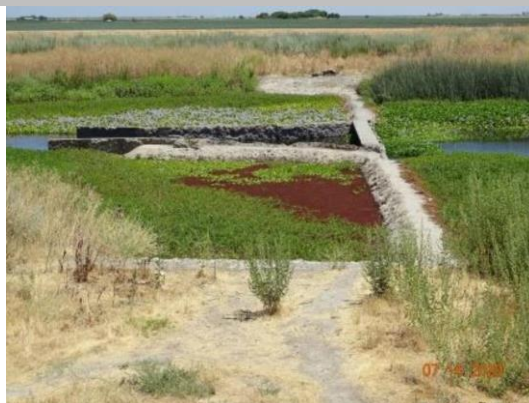
Photo 2 of 3 : ST_2020_NA0010_67_1_20200720_00006.jpg

View across the structure from the left bank. (2020)

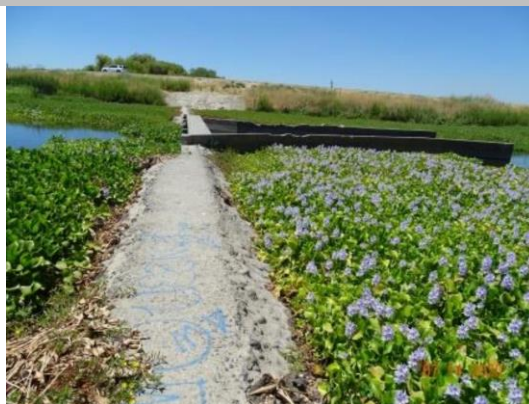
Photo 3 of 3 : ST_2020_NA0010_67_1_20200720_00008.jpg

View across the structure from the right bank. (2020)
